HIGH CORROSION PROTECTION – HCP

When corrosion  
protection  
becomes critical

# High Corrosion Protection

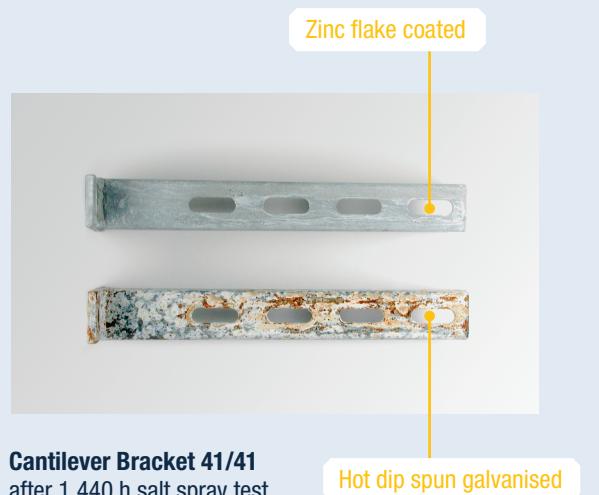
Under the umbrella term “High Corrosion Protection – HCP” we offer customised corrosion protection. Components designated “HCP” comply with the corrosivity category C4-high.

To allocate a specific coating system to one of our products, we consider factors such as the product’s functionality (e.g. threads) as well as financial implications and industry expectations.

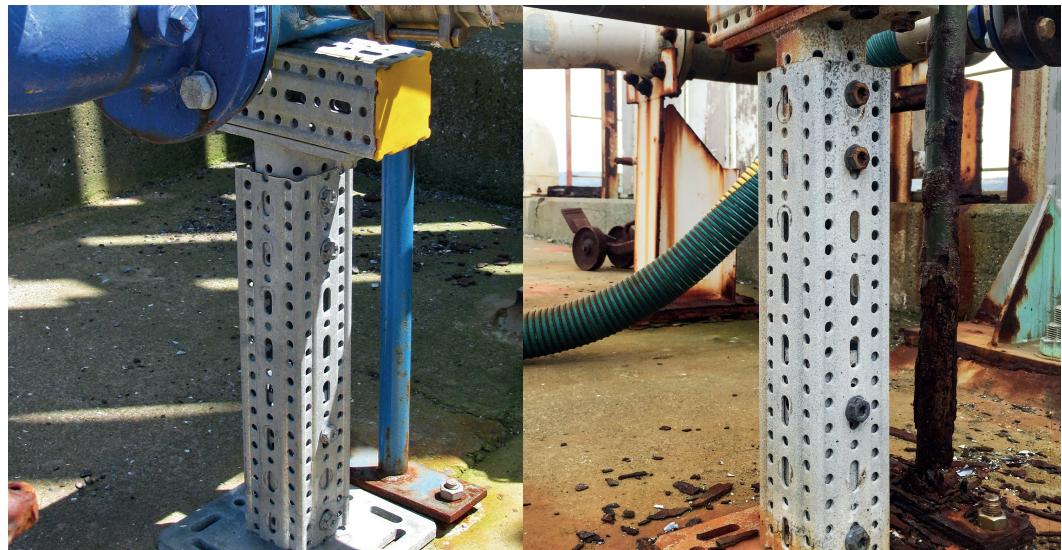
Traditional and siFramo 80 T-supports a few months after installation

After 6 years of weathering – Offshore (CX)
